COMPOSITE UNIT ACCELERATED LIFE TEST  
OF THE HIGH GAIN ARRAY

Contract Number N00014-93-C-2021

January 28, 1992

Texas Research Institute Austin, Inc. (TRI/Austin)  
Reliability Engineering Division  
A.V. Bray, S.L. Arnett, and S.C. Liberty  
9063 Bee Caves Road  
Austin, Texas 78733  
(512) 263-2101

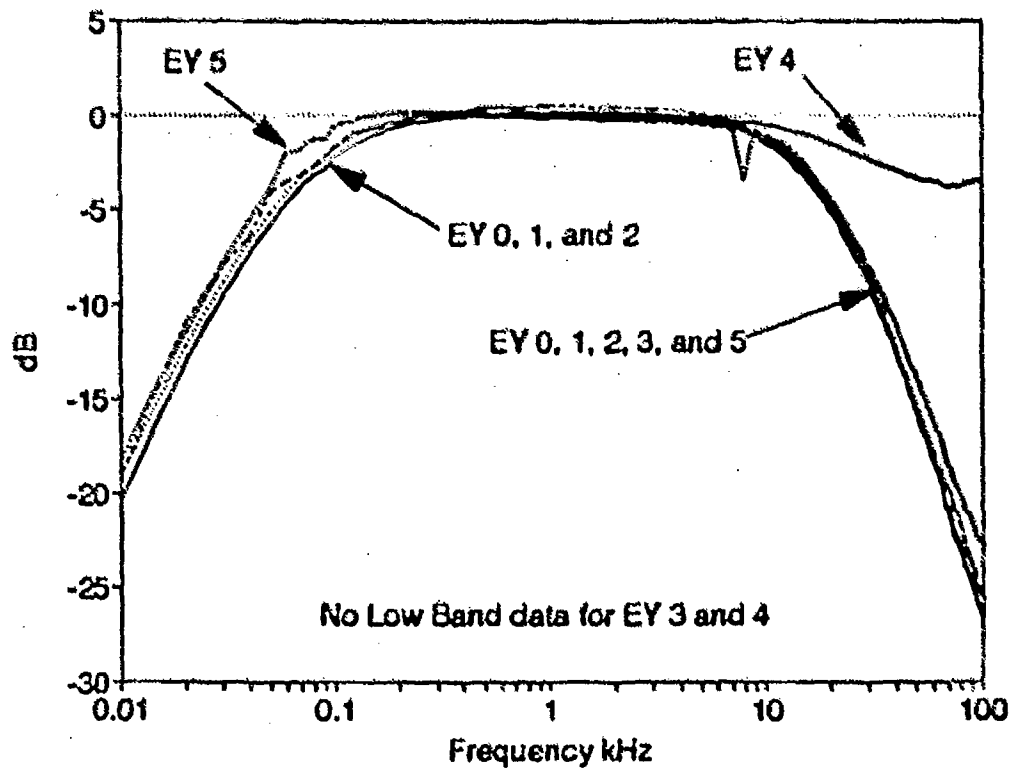
Figure 5. Hydrophone Gain Response Curves for Element H10

Figure 4 is an example set of hydrophone gain response curves for element H2 of the HGA prototype stove. Note that there is little or no variation from one EY to another for this element. Figure 5 shows the same data for element H10, whose response appears to be erratic for the EY 4 measurement period. The roll-off of EY 4 changed dramatically from the baseline data of EY 0 but was back to normal in EY 5 - an indication that the hot air exposure prior to the EY 5 measurement removed from the unit the moisture that had evidently been a problem in EY 4. The response curves for all elements are included in Appendix C.

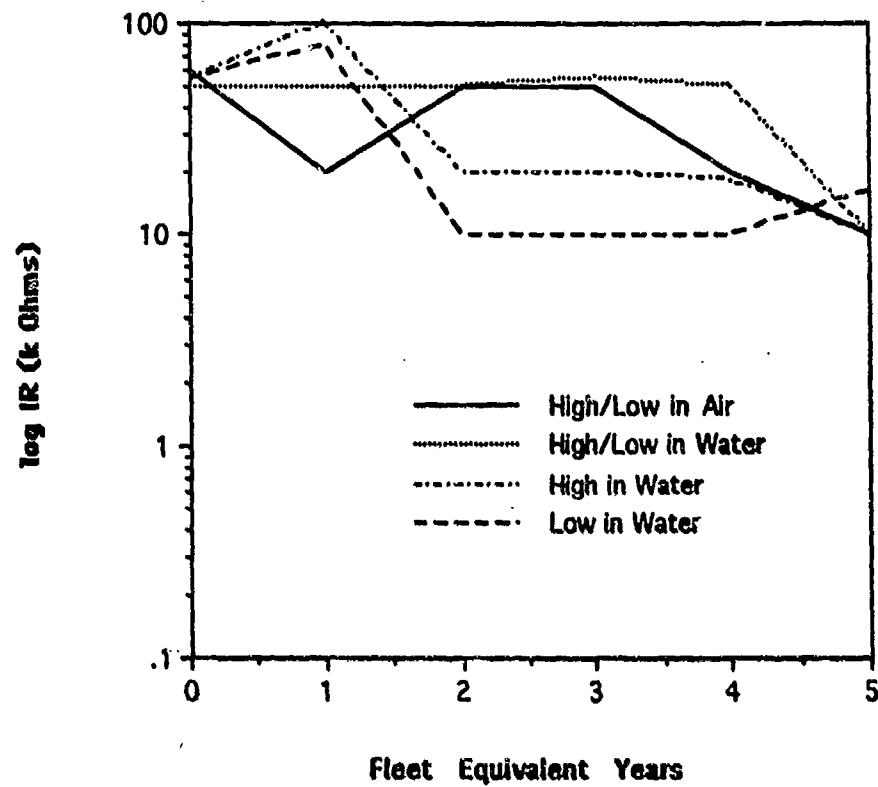
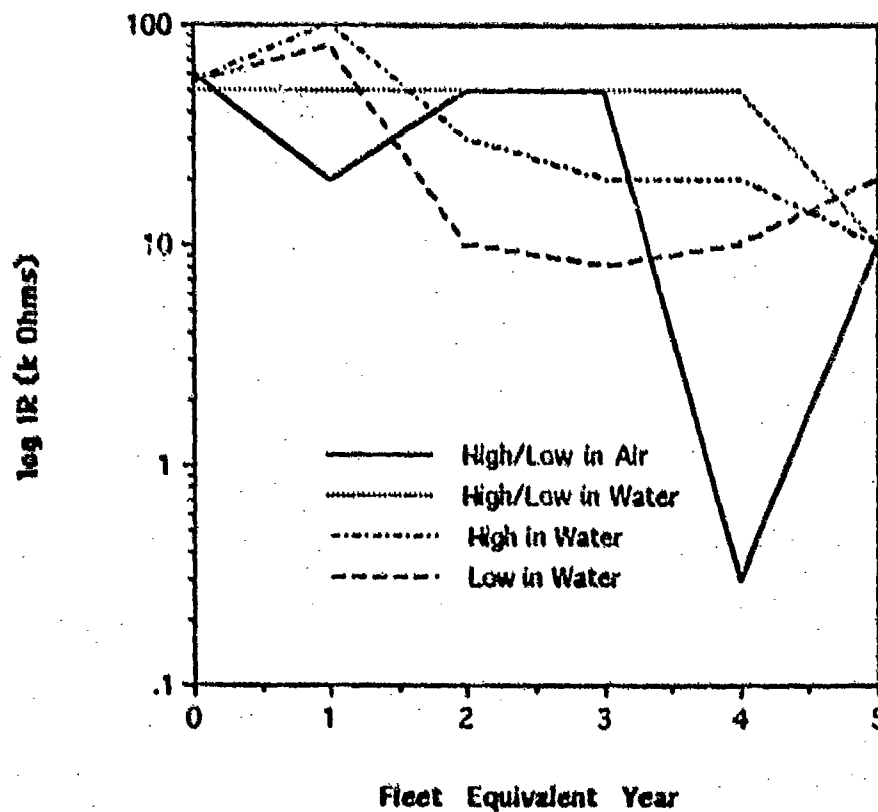
The insulation resistance data for elements H15 and H7 are shown in Figures 7a and 7b. The following comments apply to the IR data in general, and can be seen in the plots of Figures 7a and 7b:

1. Those elements which had dramatic changes in hydrophone gain response due to the dry out sequence between EY 4 and EY 5 also showed a dramatic High/Low air IR decrease prior to EY 4 followed by an increase in High/Low air IR between EY 4 and EY 5. This is another indication that these elements suffered at least partial loss of watertight integrity by the end of EY 4.

Figure 7a. IR Data for Element H15

Figure 7b. IR Data for Element H7

Due to these anomalies, elements H7, H10 and H15 are cause for concern.
